## 4.4 KENNEDY CREEK CHECK AND WASTEWAY

#### 4.4.2 Existing Conditions and Deficiencies

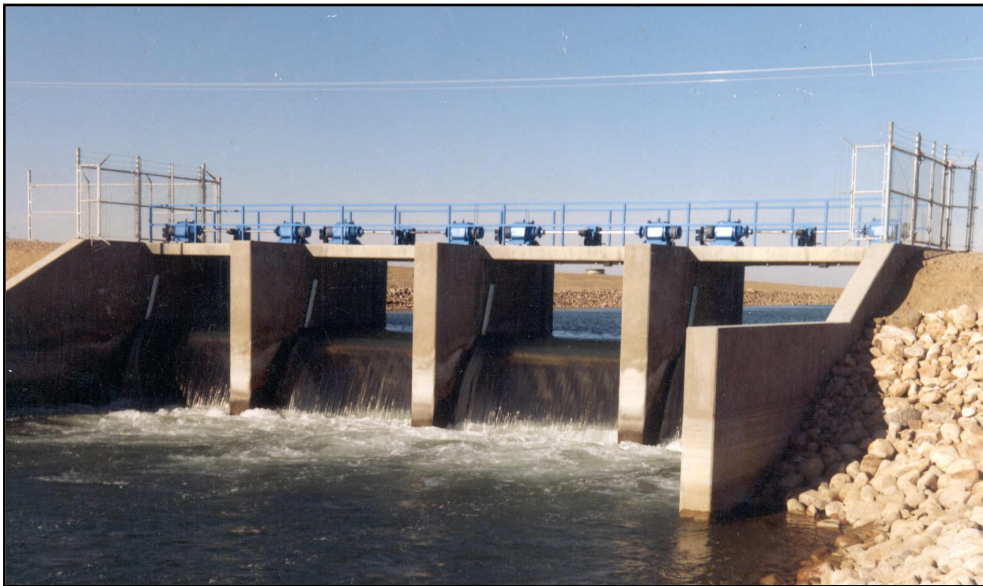
**Figure 4.4.5** Typical check structure equipped with overshot style gates.

each and a wasteway with two sluice gates 6 ft. x 6 ft. each. In our opinion, use of overshot gates in the check and wasteway structures warrants further consideration. This type of gate system has been used successfully in Canada on similar canals. An example of an overshot gate check structure is shown in Figure 4.4.5. The main disadvantage of a radial gate, especially in a check structure, is that they fail in a closed position. The BOR does not include automation in their alternatives or cost estimates but do indicate that the new structures should be designed to allow for automation in the future.
